Manhole Inspection Summary

Manhole # S33A__015MH

Insp Date: **1/13/08 12:05 PM**

Location Address: **601 HOWARD ST**

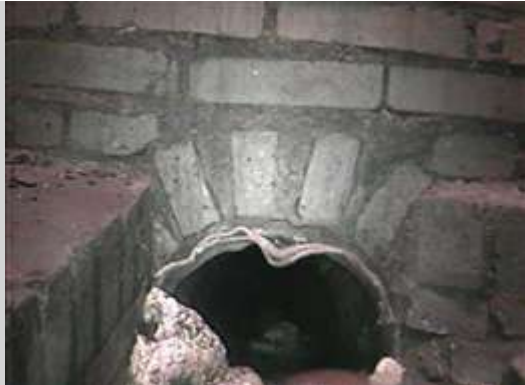
12 O'Clock Outflow

10 in. Circular Gravity Sewer
Pipe Out @ 12 O'Clock

Pipe Height: (in.) Direct
Pipe Material: **Clay** ☒ Pipe Lined
Invert Depth: **13.84** (ft.) Flow Characteristics: **Fast**
Deposits: ☒ None ☐ Mud ☐ Sludge ☐ Debris ☐ Grease
Silt Depth: (in.) Deposits Extent:
Infiltration: **None** Pipe Seal Cond: **Sound**

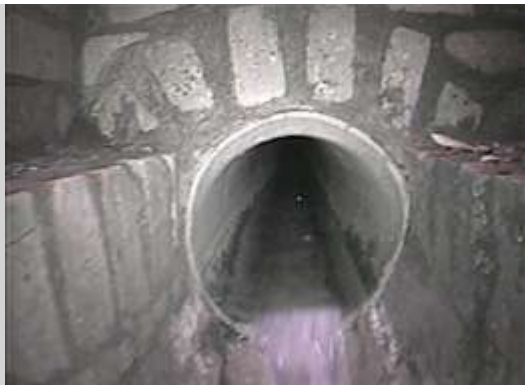
3 O'Clock Inflow

8 in. Circular Gravity Sewer
Pipe In @ 3 O'Clock

Pipe Height: (in.) Direct
Pipe Material: **Clay** ☒ Pipe Lined
Invert Depth: **13.95** (ft.) Flow Characteristics: **Fast**
Deposits: ☒ None ☐ Mud ☐ Sludge ☐ Debris ☐ Grease
Silt Depth: (in.) Deposits Extent:
Infiltration: **None** Pipe Seal Cond: **Sound**

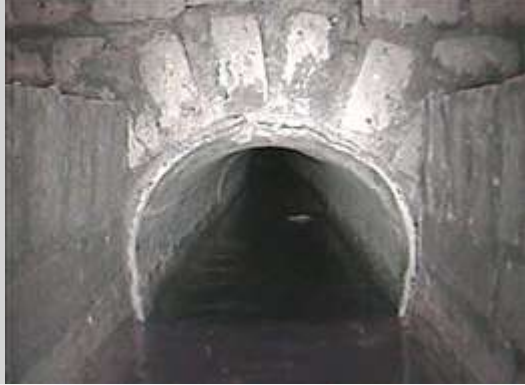
6 O'Clock Inflow

10 in. Circular Gravity Sewer
Pipe In @ 6 O'Clock

Pipe Material: **Clay** ☒ Pipe Lined

Invert Depth: **13.99** (ft.) Flow Characteristics: **Slow**

Infiltration: **None** Pipe Seal Cond: **Sound**
